Results of inspection [REDACTED]

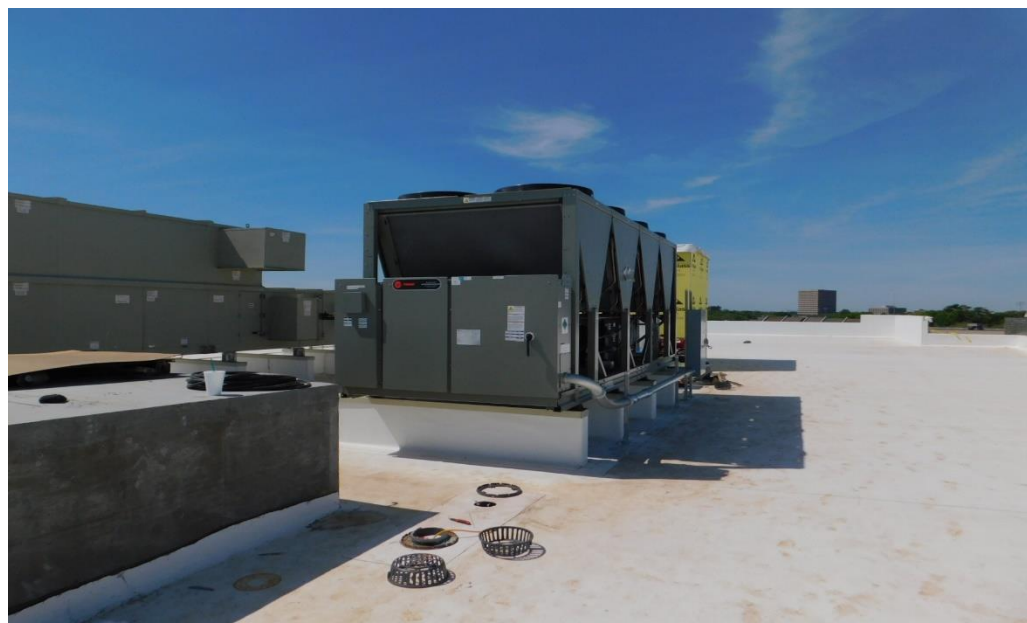
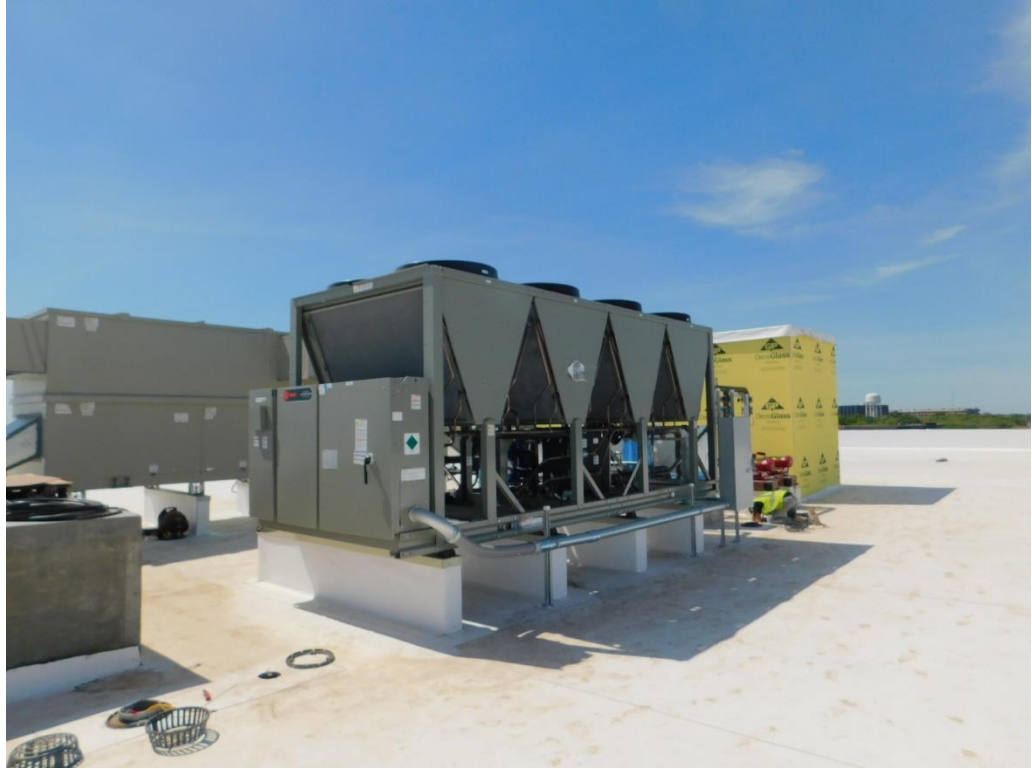
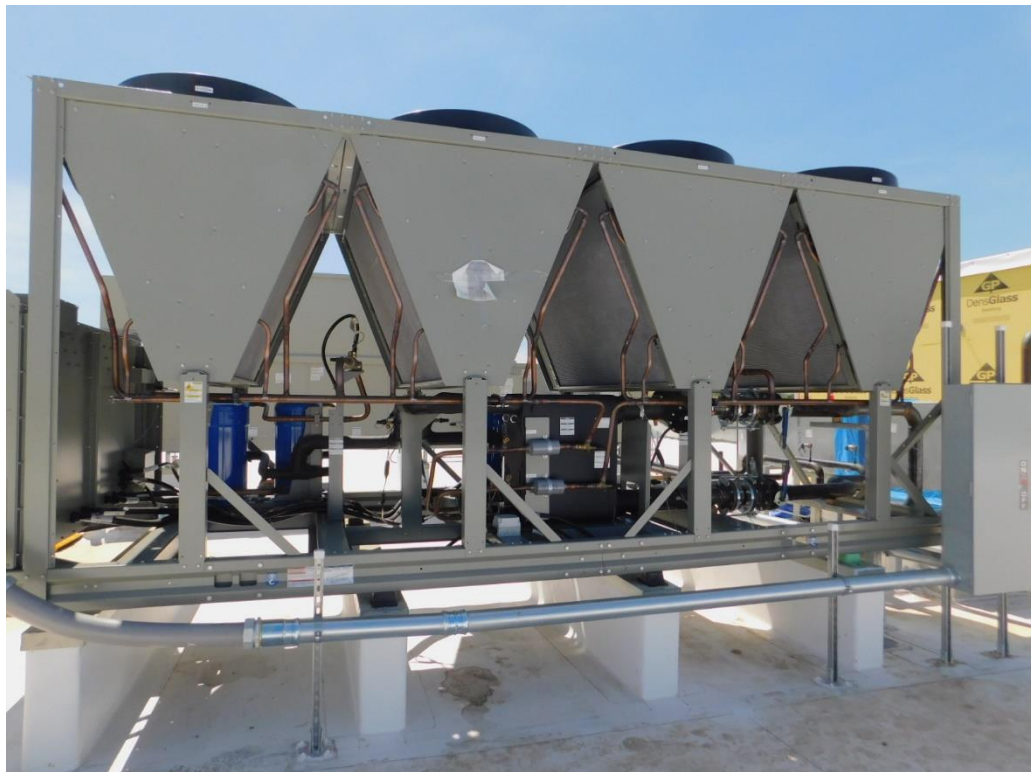
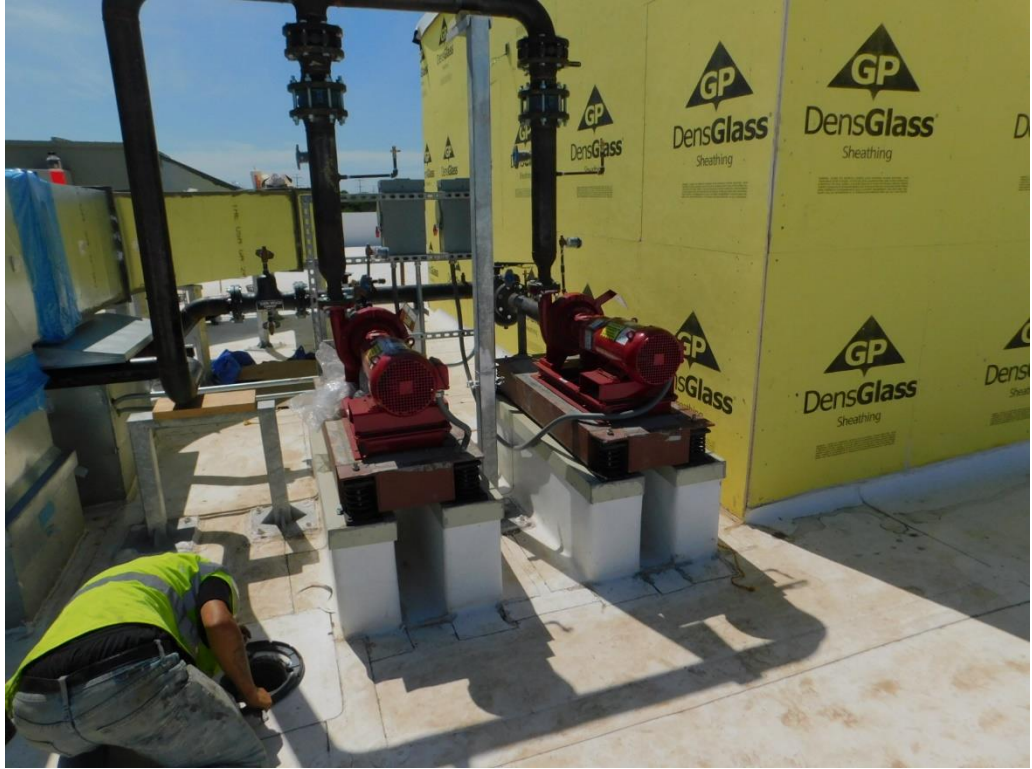
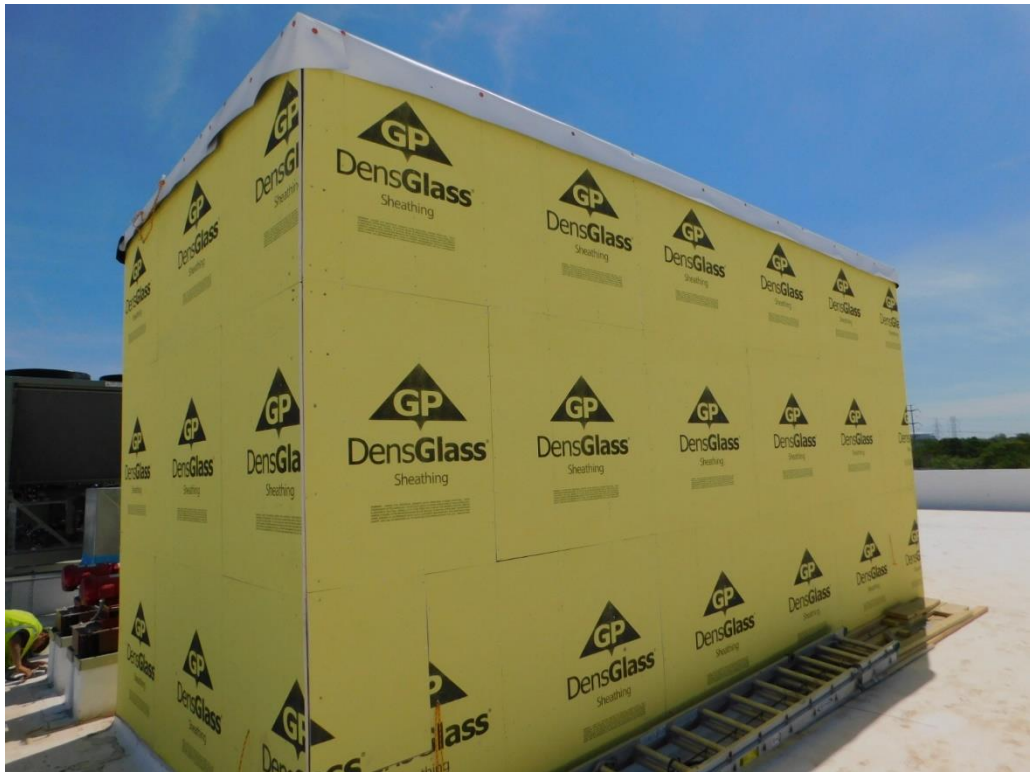
1. The building structural steel has been completed. Roof has been installed with HVAC and other equipment in place.

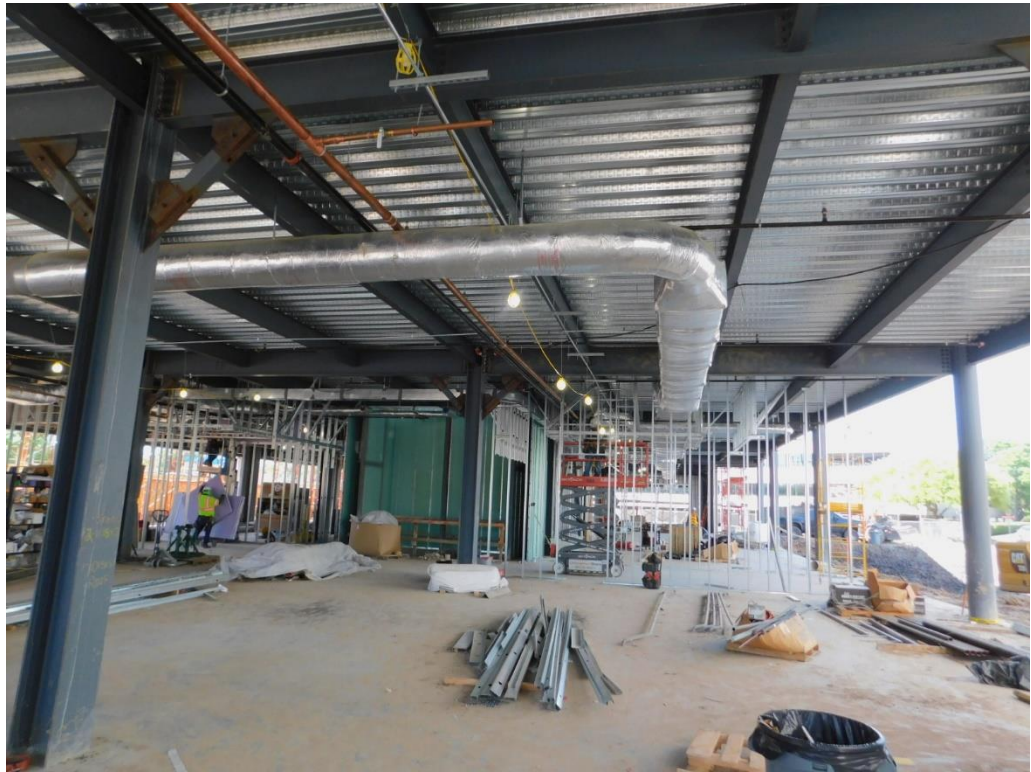
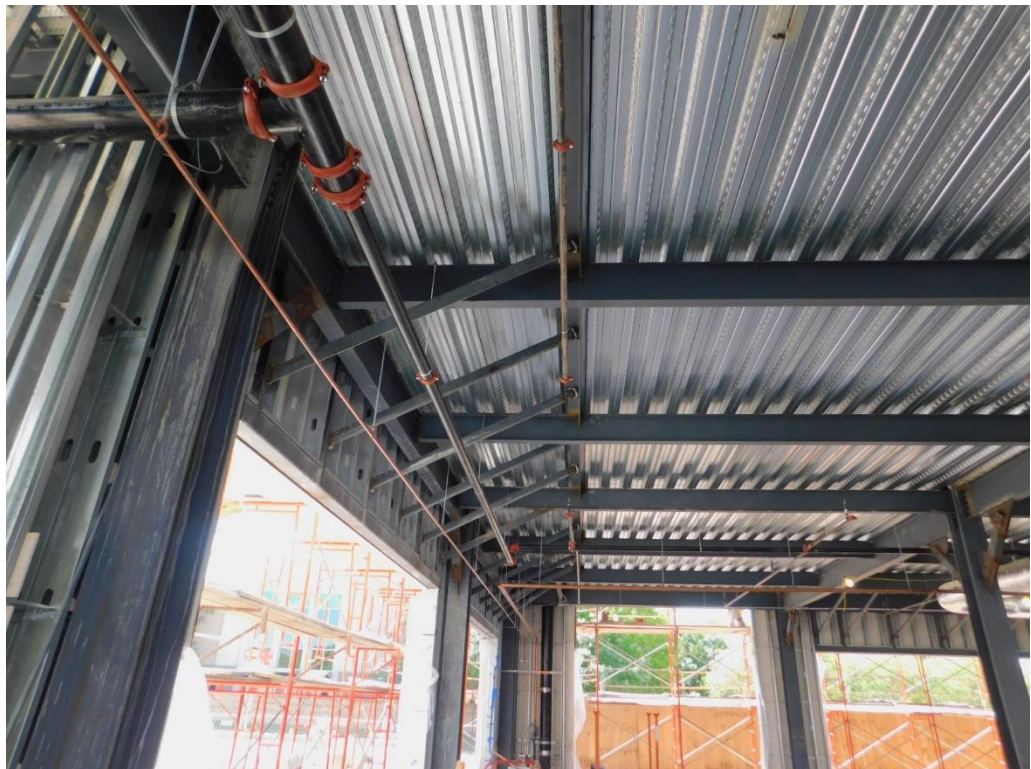
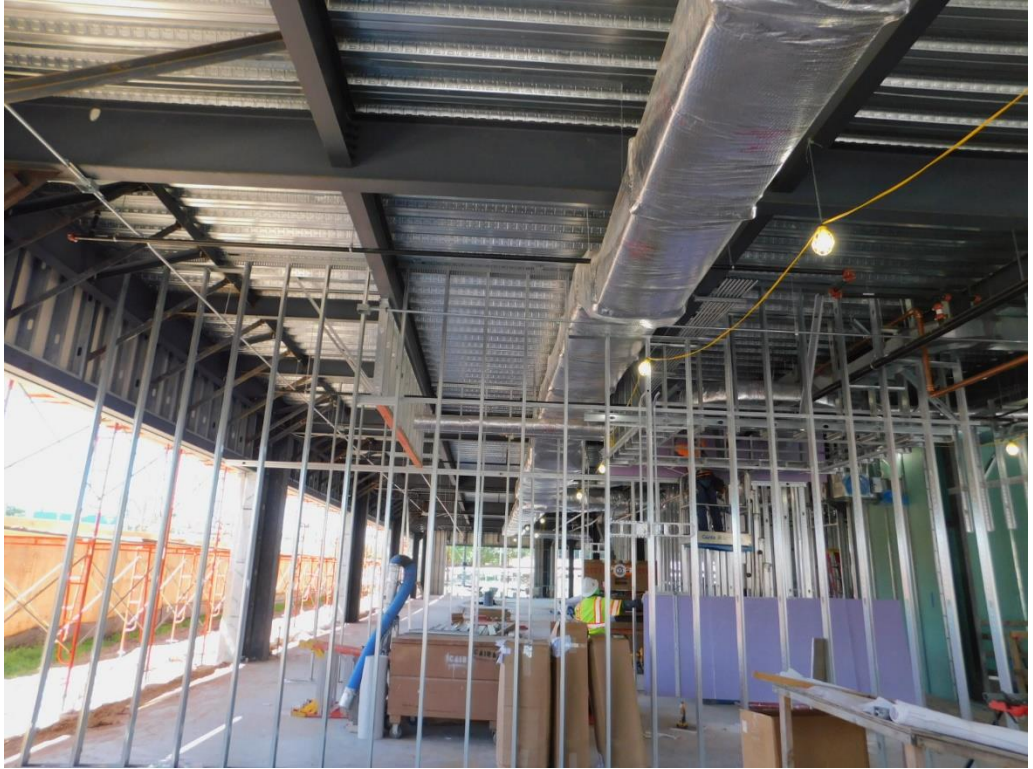
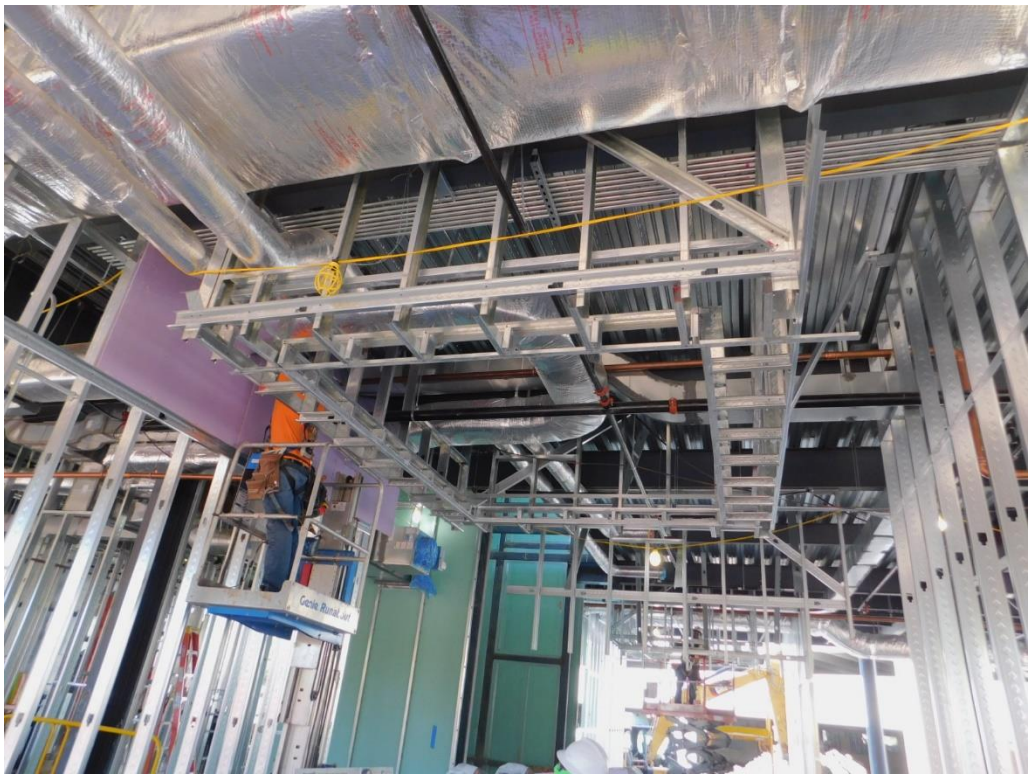
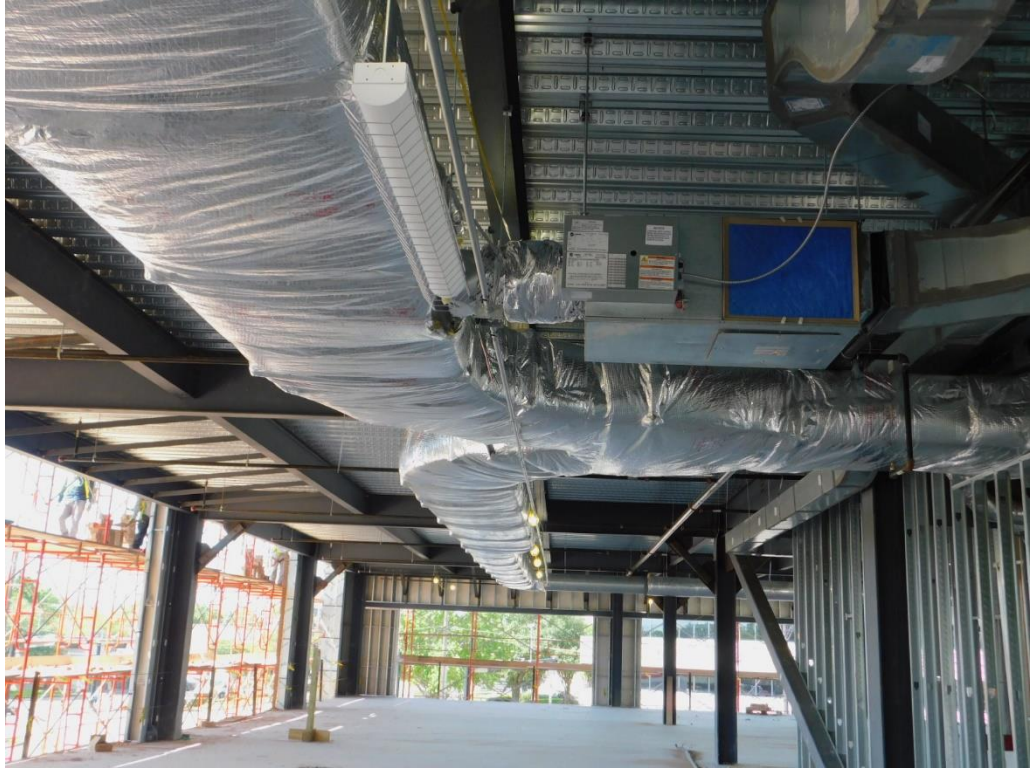
2. HVAC and sprinkler system have been installed on floors 1, 2 & 3.

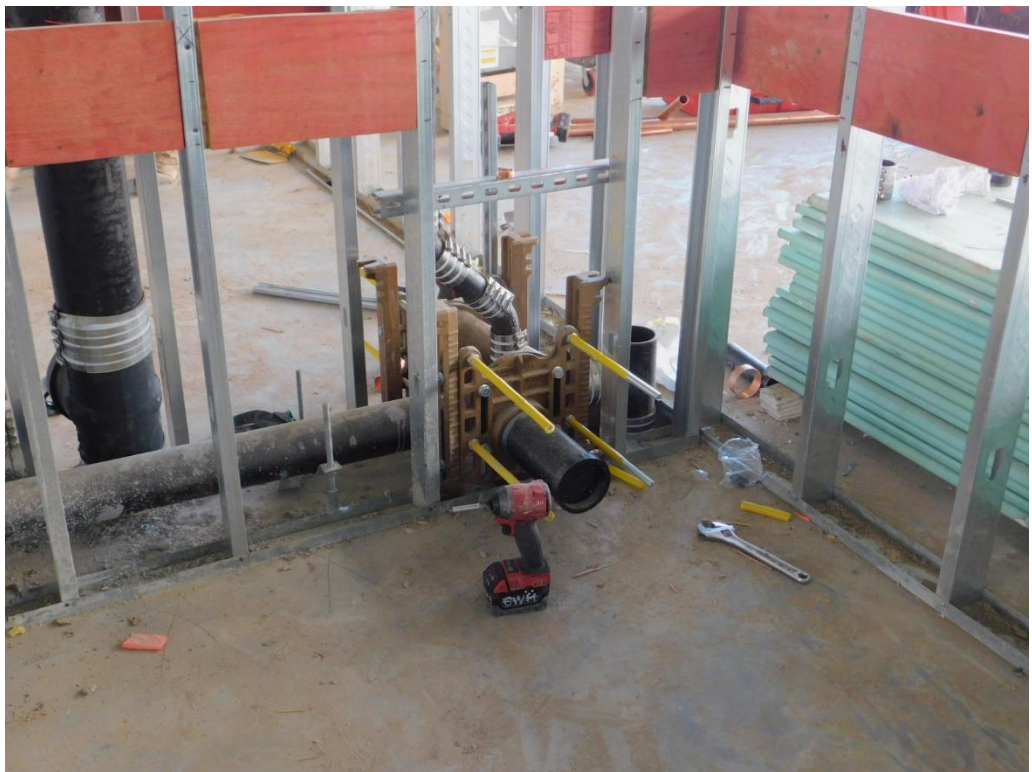
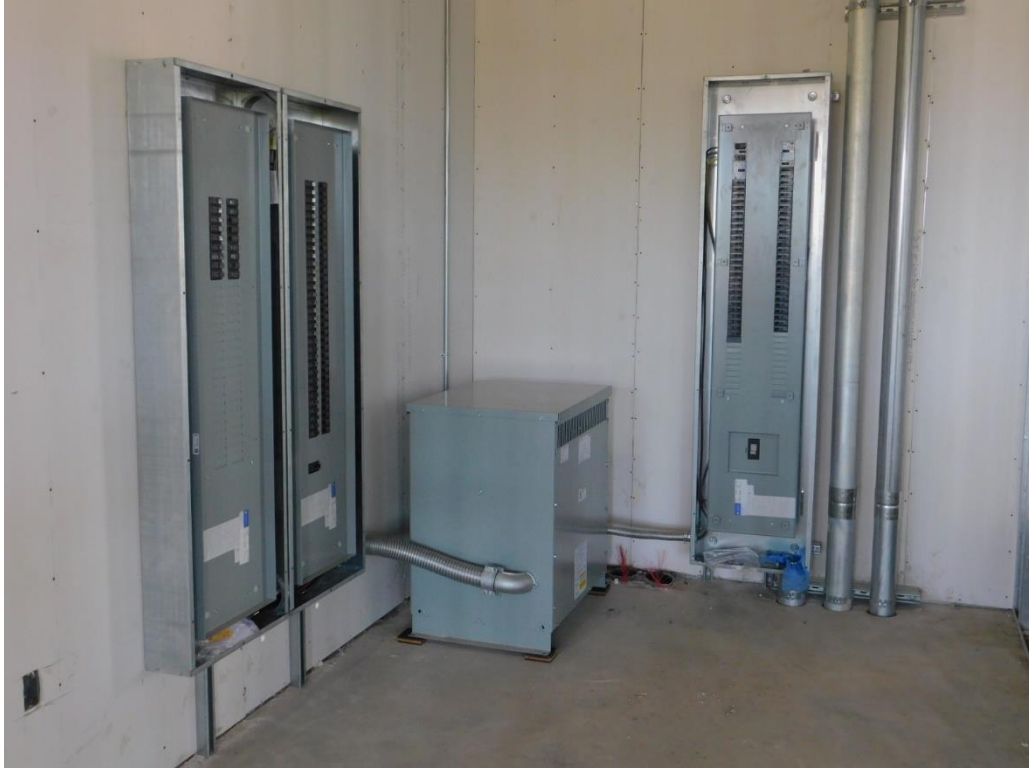
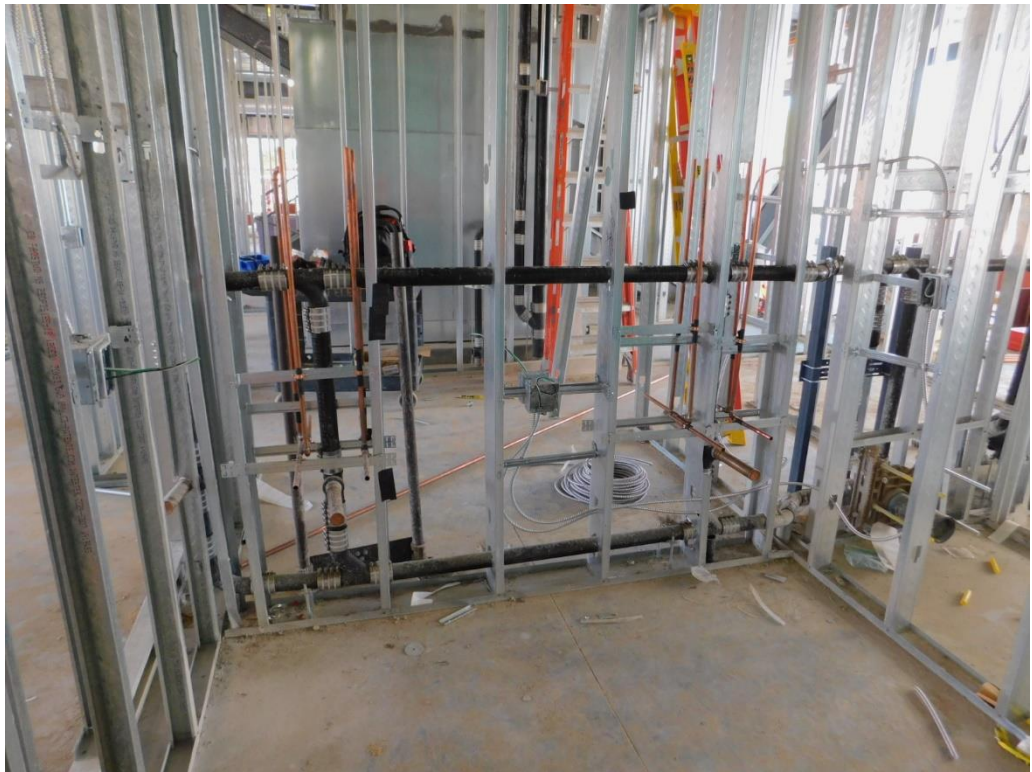
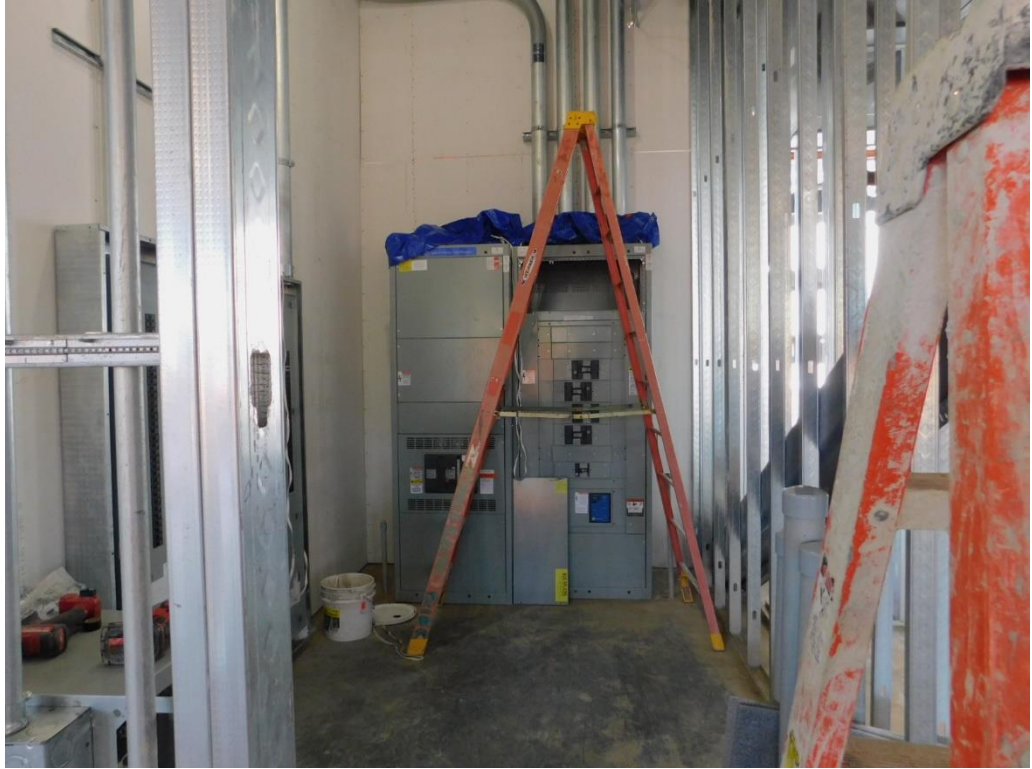
3. Electrical and plumbing roughed in on each floor.

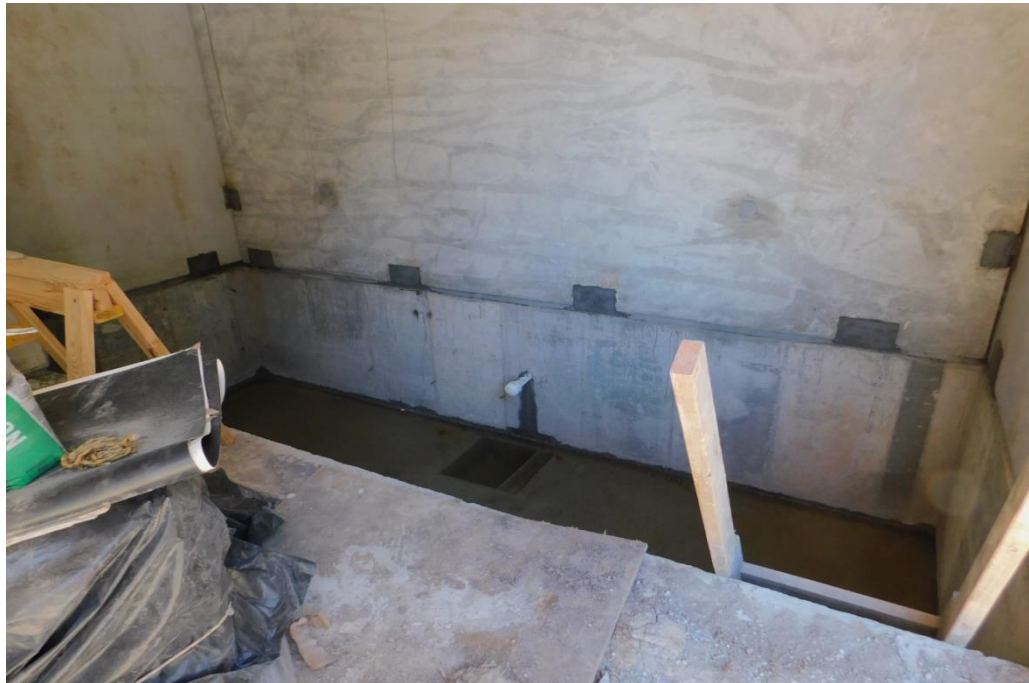
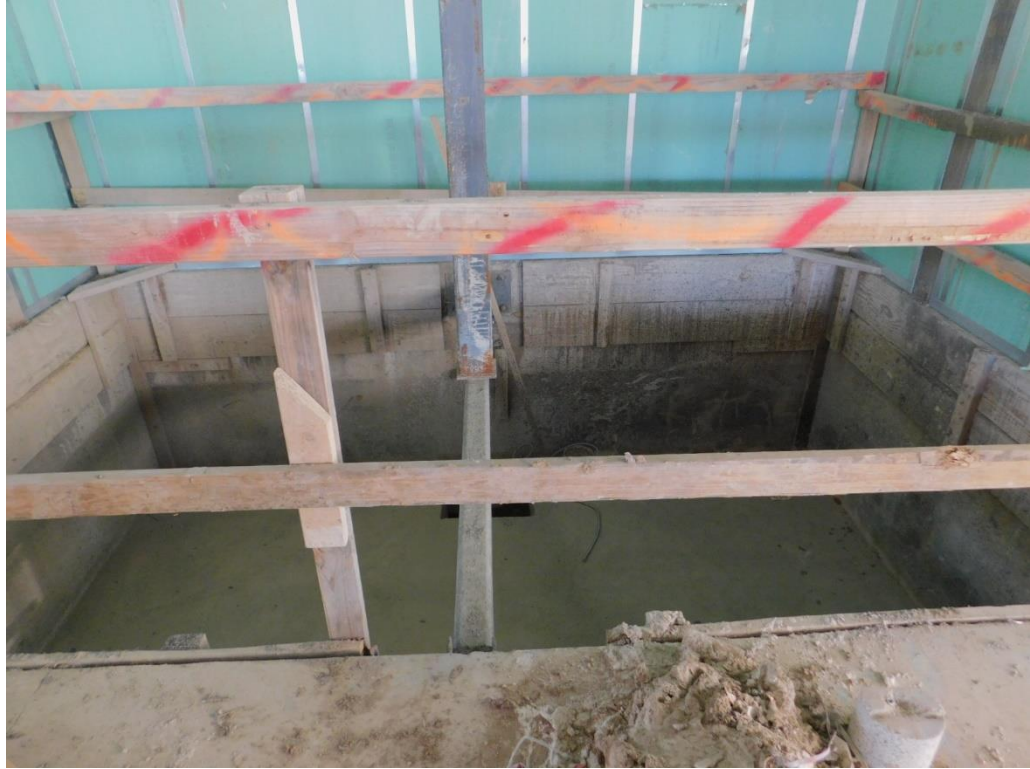
4. Elevator pits awaits elevators. Invoice from [REDACTED] supplied previously.

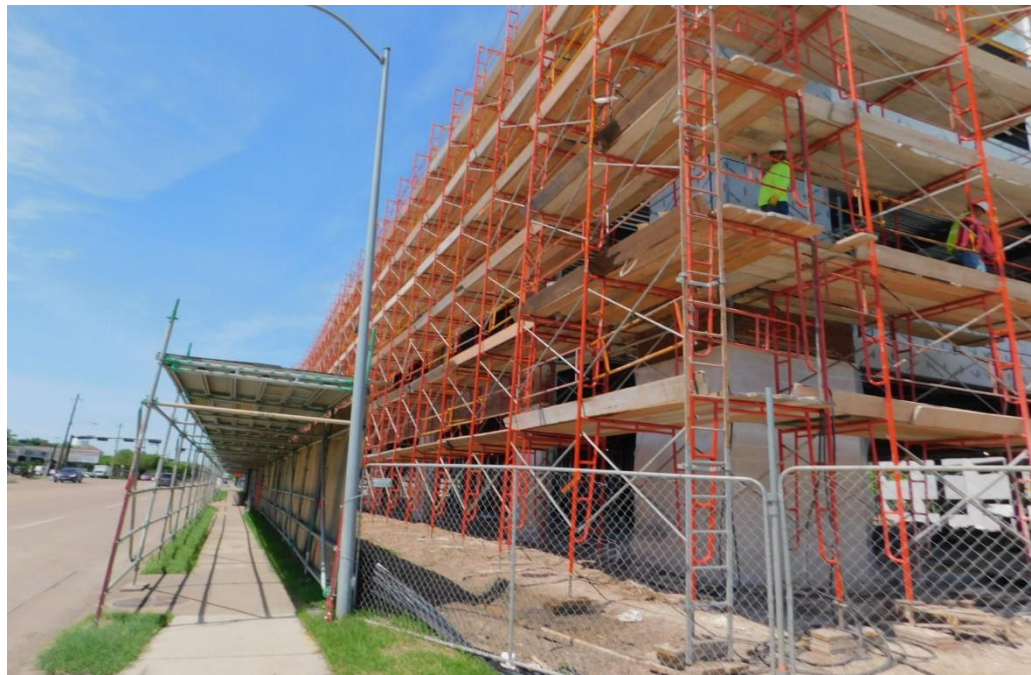
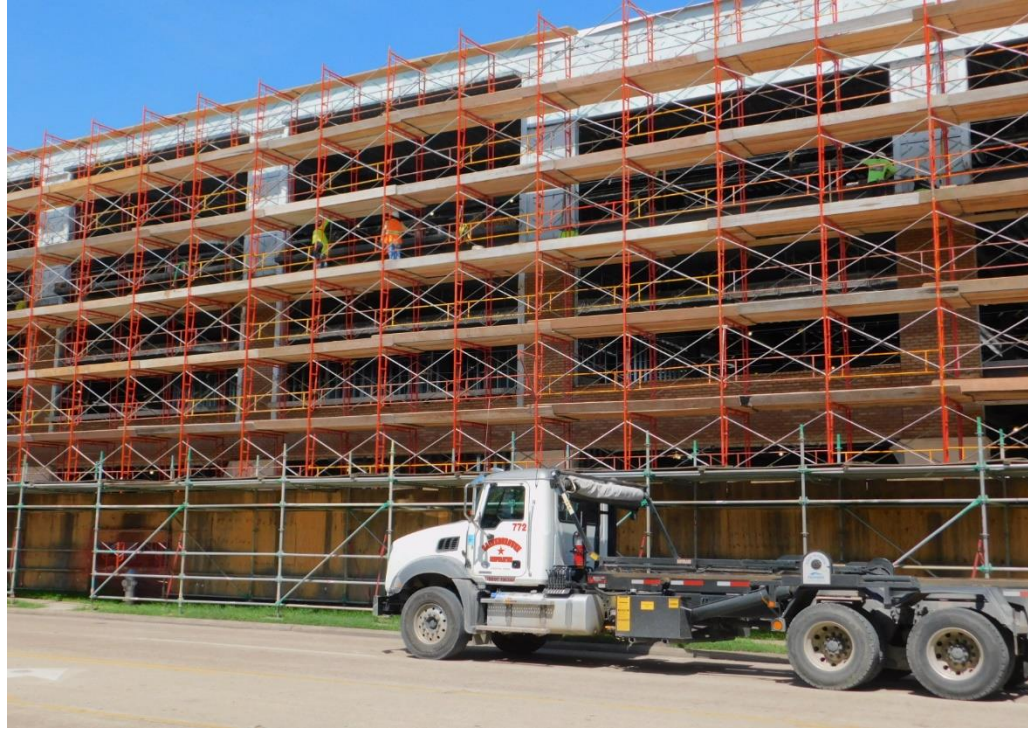
5. Brick work has begun on front of building.

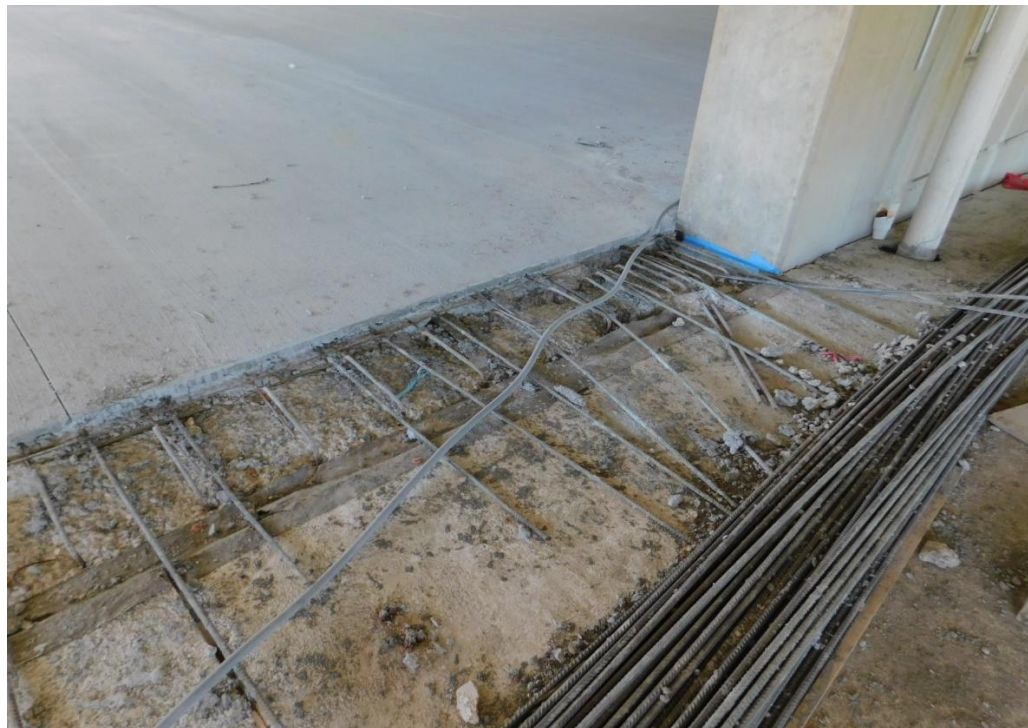
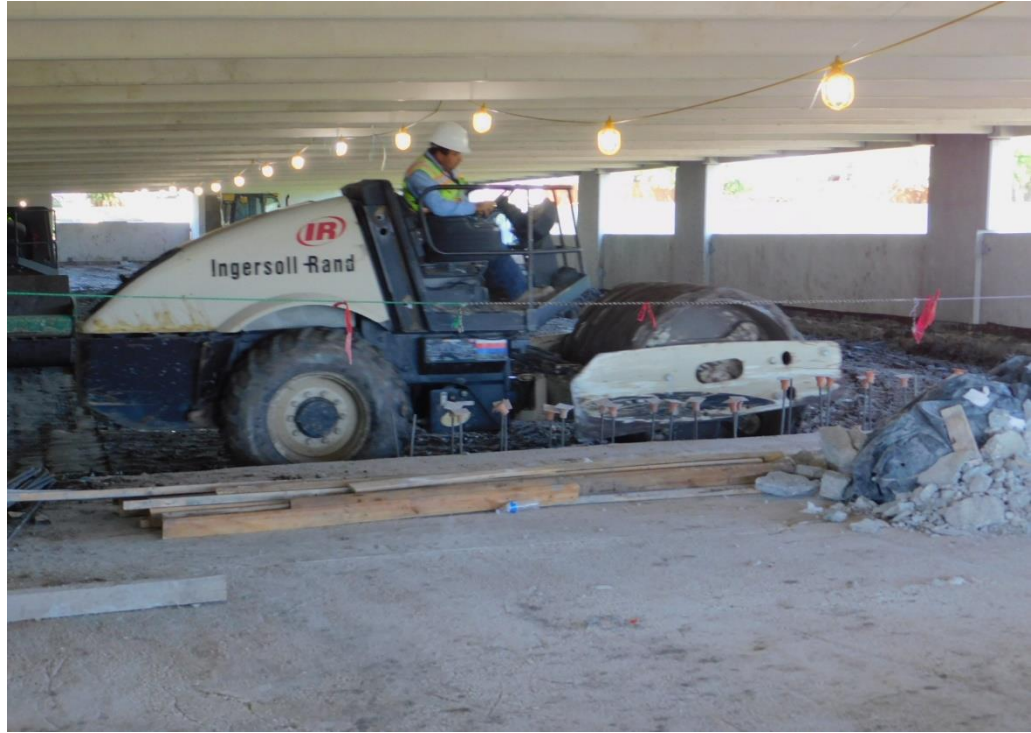
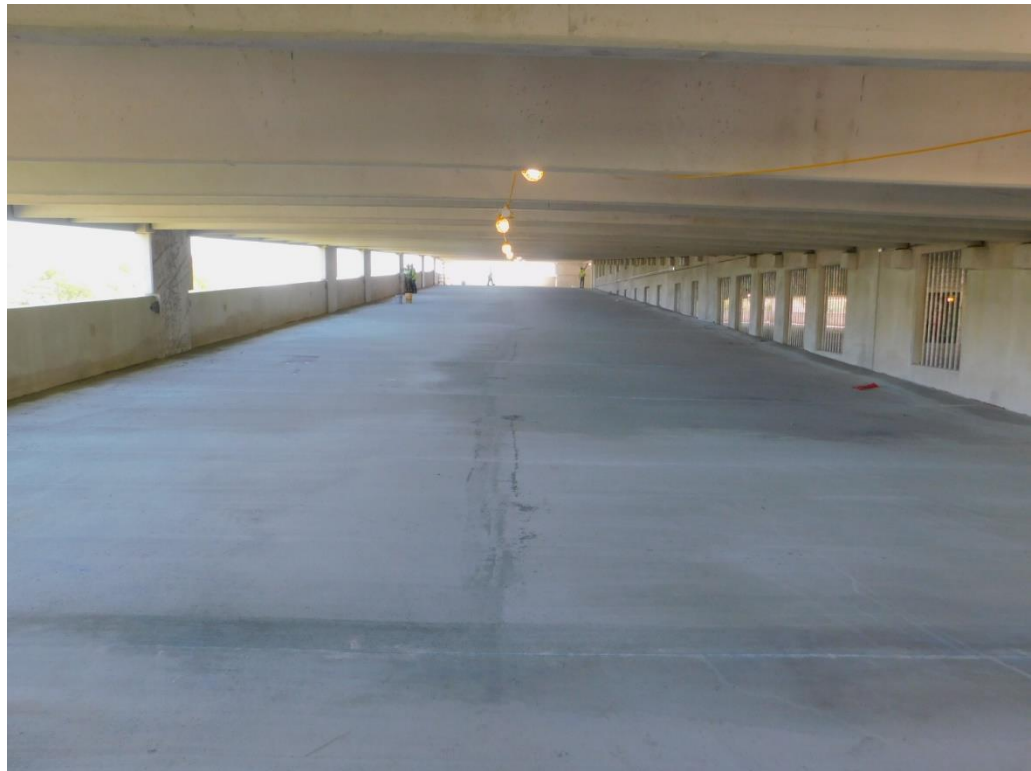
6. Erection of garage panels and I-beams are complete. Concrete overlay has been poured on levels 2 through 6 with 3+/-" concrete. Working on ground level and ramp up to level 2.

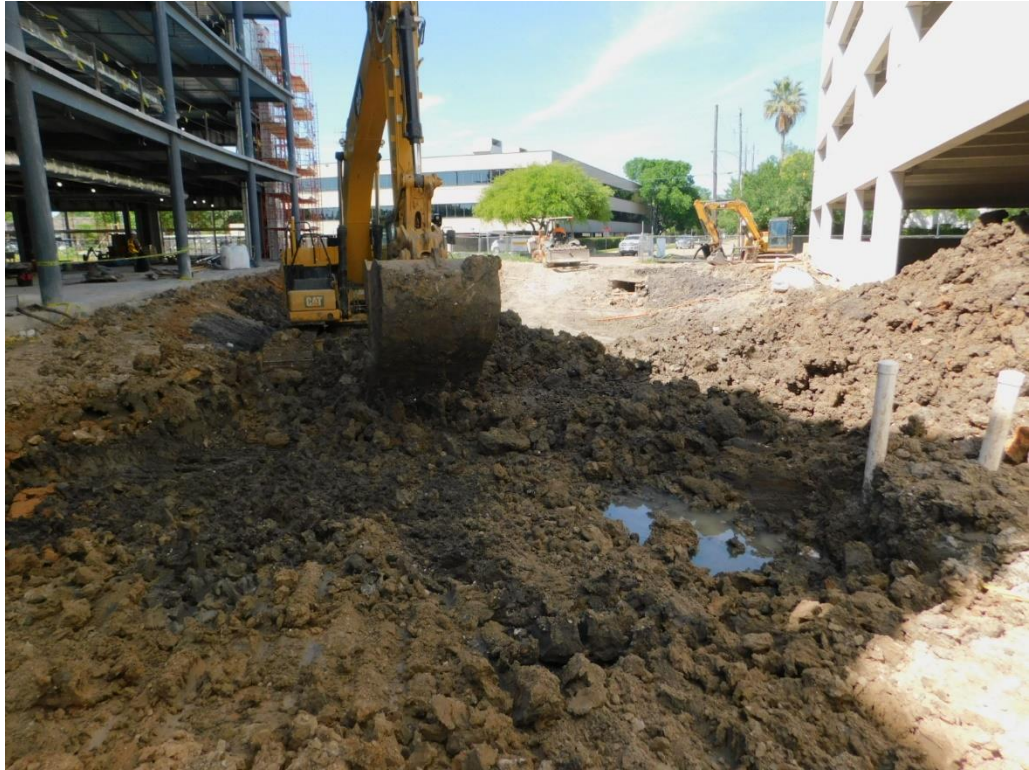
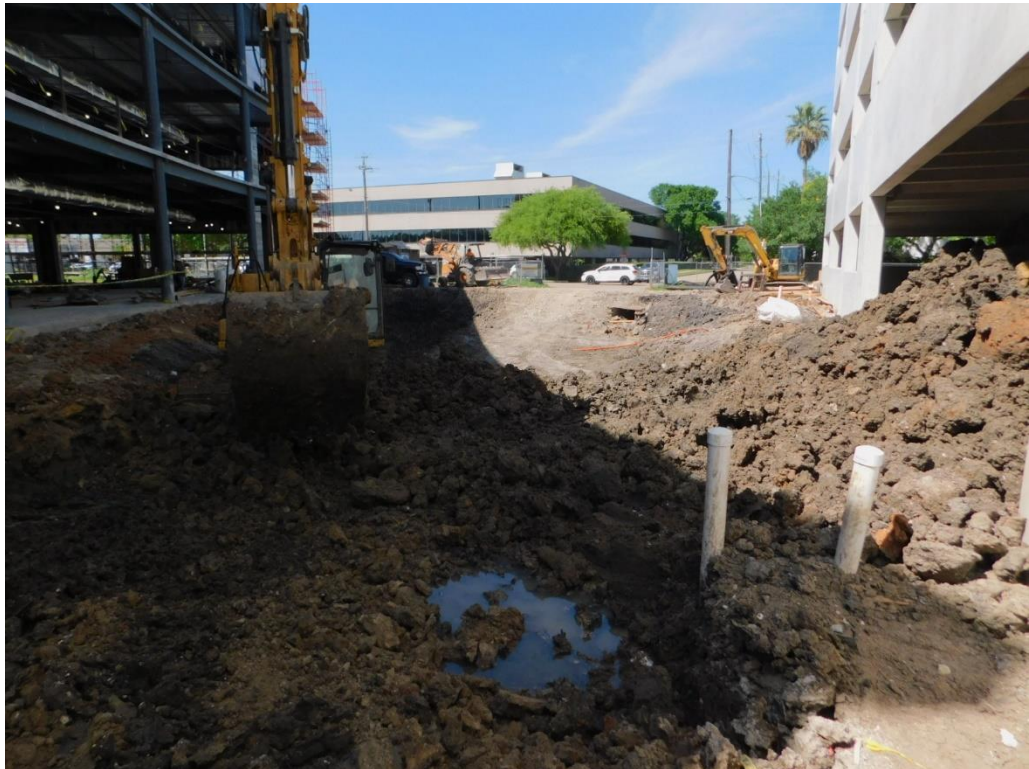
7. Excavation for underground detention is progressing between building and garage.
